# Underwater Survey & Inspection of Main Marine Dock & Anchors

**May 27, 2025**

**Honeymoon Bay Resort Association**

**ISLAND  
FLOATATION** LTD

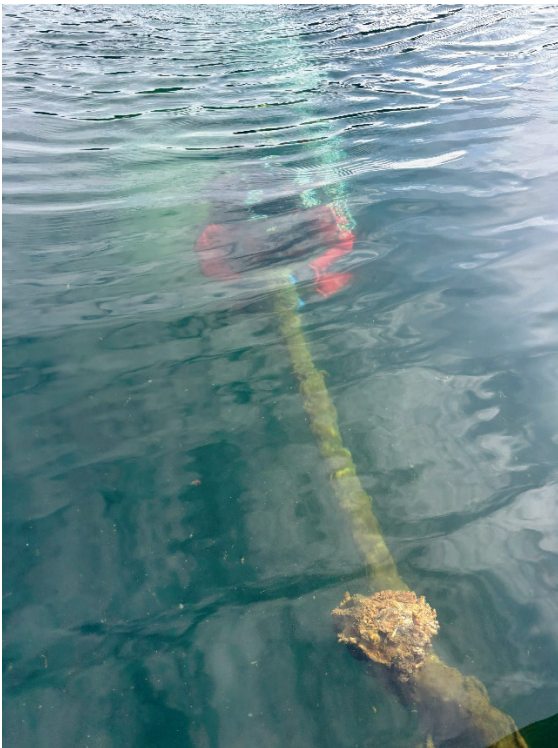
Figure 1 - Checking Lines

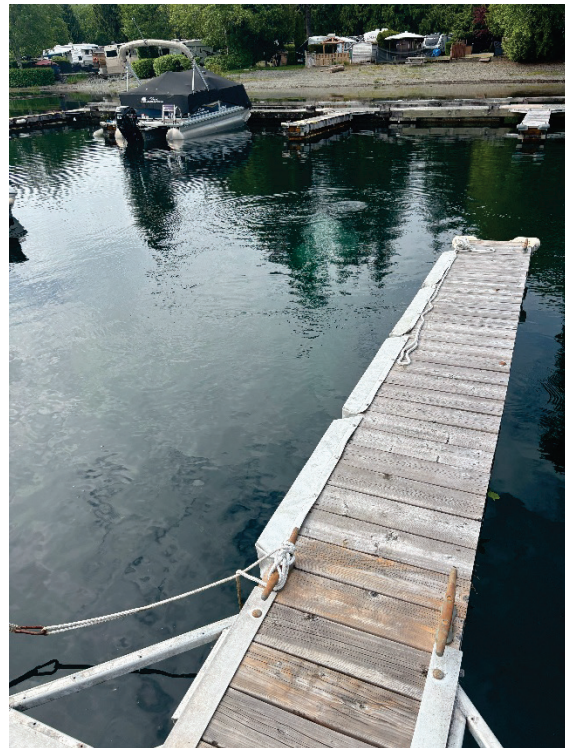
Figure 2 - Bubbles indicating anchor locations

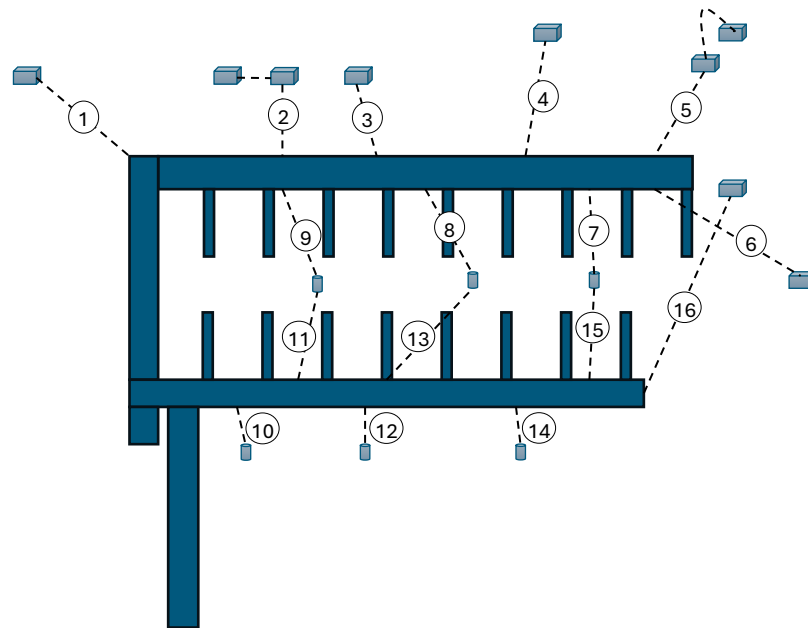
## Marine Dock Diagram

*Original diagram revised to reflect actual anchor system.*

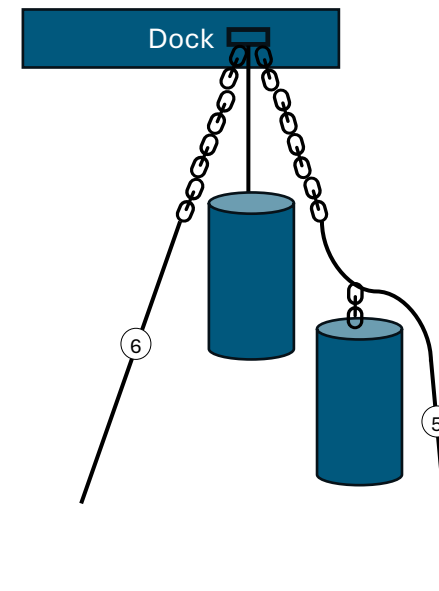
*Diagram of Line 5/6 dock connection*

The dock connection point where Lines 5 and 6 are attached is being stressed to potential failure. This is due to the weight of everything being connected to a single eyebolt and timber. Some bending of the timber was noted. It is recommended that the lines be redistributed to two or more connection points – preferable on a different timber – to alleviate the stress. More details of this issue can be found in the next section.

| Line | <sup>1</sup> Chain Strength | | Anchor Depth | <sup>2</sup> Anchor Type & Position | General Observation |
|---|---|---|---|---|---|
| <b>5</b> | 7 | 8 | 75' | 2T LB (2) / Good | 12' of chain to 4" rope tied on down to barrel anchor (suspended). Rope from that barrel anchor to 1 <sup>st</sup> lock block anchor. From the 1 <sup>st</sup> lock block a rope is tied on and goes to deeper water and is attached to a 2 <sup>nd</sup> lock block – the rope between the two lock blocks is slack and floats upwards.<br>From the same eyebolt at the dock, another chain is attached and has a barrel anchor attached (suspended). The eyebolt also has Line 6 attached to it. See detailed drawing. |
